U. S. Army Rotary-Wing Emergency Egress Study

Timothy R. Swingle

U.S. Army Aeromedical Research Laboratory
Fort Rucker, Alabama 36362-0577

11. TITLE (Include Security Classification) (U) U.S. Army Rotary-wing Emergency Egress Study						
12. PERSONAL AUTHOR(S) Timothy R. Swingle						
13a. TYPE OF REPORT Final		13b. TIME COVERED FROM _____ TO _____		14. DATE OF REPORT (Year, Month, Day) 1995 May		15. PAGE COUNT 33

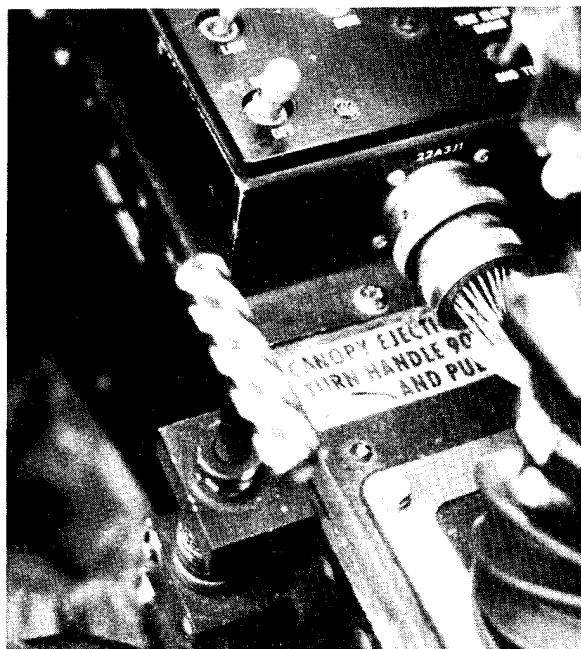
Figure 14. AH-1 copilot/gunner emergency egress handle.

Cockpit only --- The Cobra contains a canopy jettison system that can be operated from either the pilot's rear seat or the copilot/gunner's, (CPG) front seat. The arming/firing mechanisms are located near the instrument panel and have operating instructions on them as shown in Figures 13 through 17. These firing mechanisms are operated by turning the handle 90 degrees counterclockwise with a torque of 6-12 inch-pounds. This maneuver arms

the assembly. The operator then pulls the handle with 20-35 lbs. of tension, firing the primer and causing the cutting assembly to be detonated. The process is completed by the detonation cord, that burns around the periphery of all the side panels, sever-

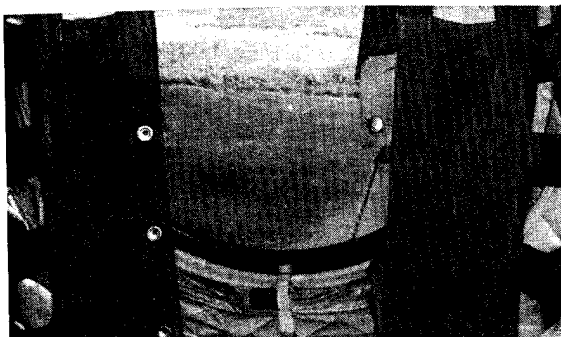
Figure 32. CH-47 cabin area emergency egress window straps.

emergency exit on the ramp shell, the shell itself, or exiting through the cargo hook viewing hatch. The windows are jettisoned by pulling a yellow strap hanging from each window as shown in Figure 32. The strap is connected to a seal that runs completely around the window. Pulling the strap away breaks the entire seal and the window then can be pushed out. In addition to the window, a square panel around the window comes out with the front exits on either side, and the exit located on the ramp shell. Adequate instructions for operating these emergency exits are located near the exits and in chapter 9 of the operator's manual as shown in Figures 34 and 35.
